OTC 18844

“Special Session: AUVs: Groundtruthing High-Resolution AUV Side Scan Sonar Contacts for Unexploded Ordnance in a Deepwater GeoHazard Assessment”

Lynn B. Samuel, C & C Technologies, Inc., and John E. Herbert, Applied Marine Technology, Inc.

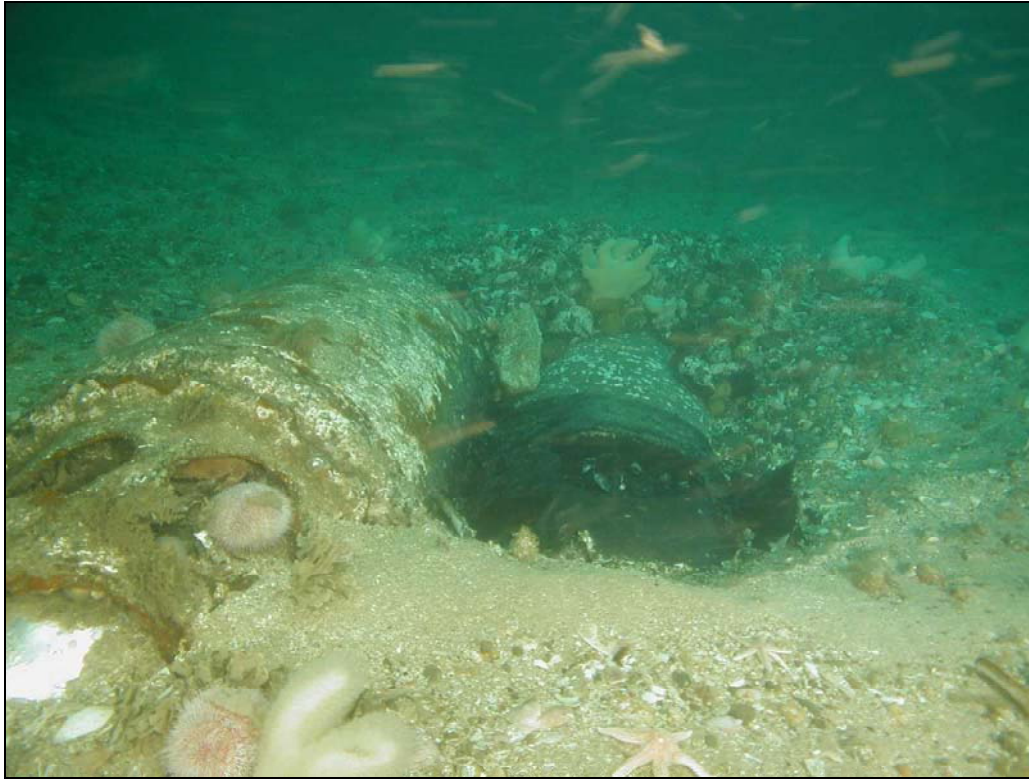
Figure 2: Possible G-Series WWII German ground mine resting in 157 feet of water, adjacent to a pipeline in the North Sea⁵.

Unexploded Ordnance (UXO) throughout the world's oceans continues to be a hazard and will be for some time to come. The North and Caspian Seas are a perfect example of this. The North Sea is littered with live ordnance⁷ (Figure 2) with numerous accounts of inadvertent detonations during evolutions at or near the oceans bottom, damaging or destroying equipment and infrastructure and placing humans in imminent danger. There are also accounts that the Caspian Sea has been used as a UXO dumping ground. These UXO, some of which are presumed to be fuzed, were likely dumped during the Russian – Iranian Naval battle, and from excess Russian inventory along with other Former Soviet Union countries⁸. Numerous companies that are producing oil and gas fields in the North Sea and exploring the Caspian Sea are also exploiting deepwater fields surrounding the United States.

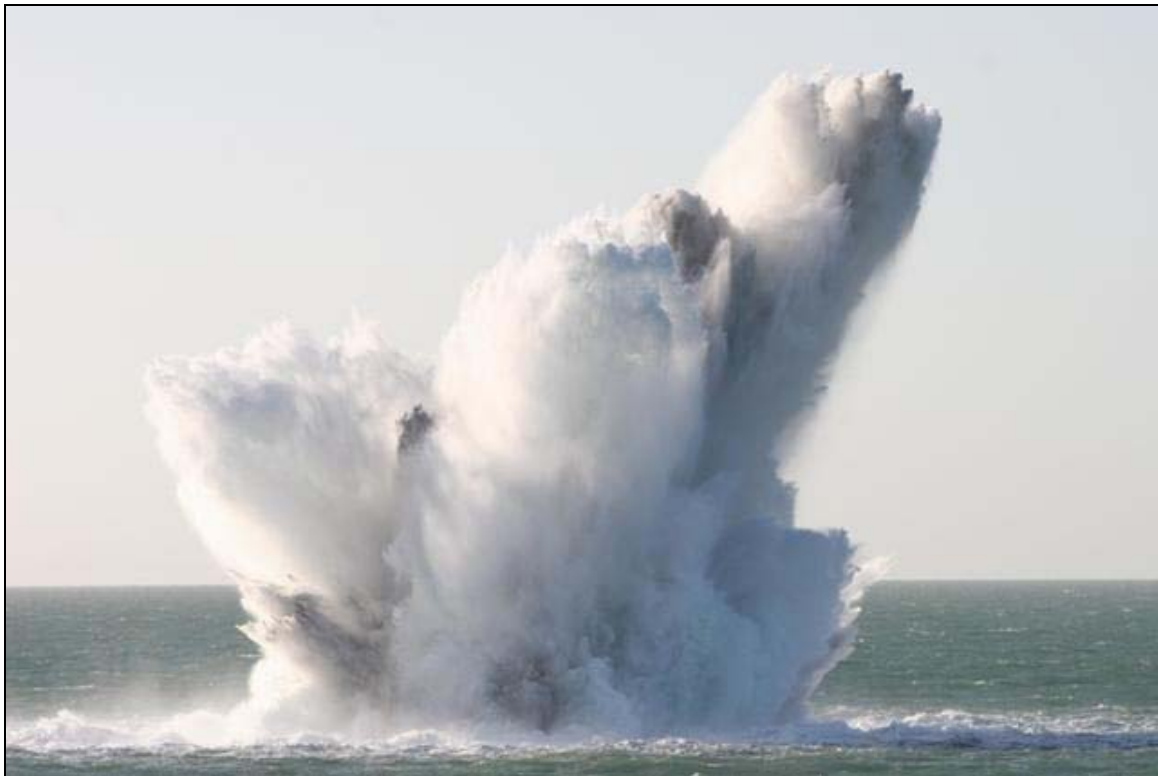
Figure 3: Intentional Detonation of a G-Series WWII German ground mine in the North Sea⁵.

With their primarily metal construction, detection of UXO items is usually less difficult than discrimination and identification. The real expertise lies in the ability to discriminate between UXO items (proud or buried) and other discarded items that are commonly found on the ocean floor. Discrimination is critical in reducing false positive UXO identifications, while identification allows ordnance specialists to choose the proper disposal procedure such as render-safe, blow-in-place (intentional detonation; Figure 3), or removal.

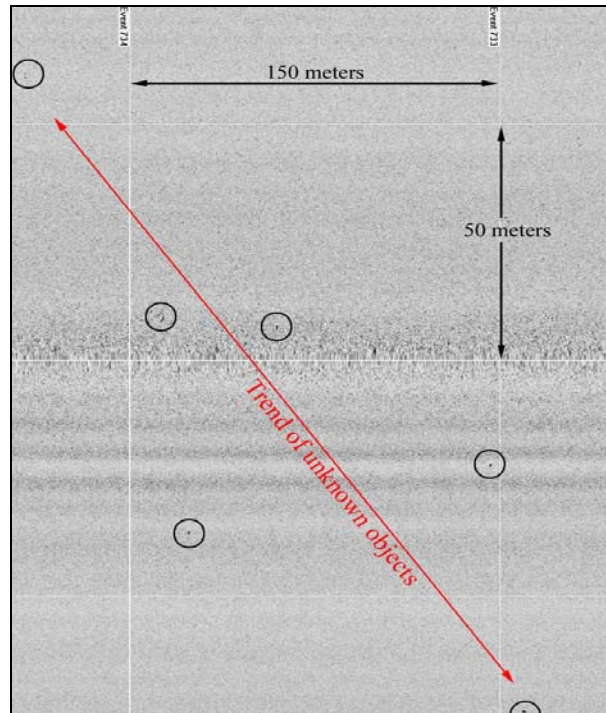
Figure 4: Trail of unknown sonar contacts in 410 kHz AUV side scan sonar data.

The pre-planned acquisition of high-resolution, 410 kHz, side scan sonar data within the critical areas suspect to contain UXO, revealed a trend of unknown sonar contacts on the seafloor. Figure 4 presents a sample of this high-resolution AUV data. The linear debris zone, actually located more than 3 miles outside of the designated boundary of the munitions dump, was interpreted as a possible string of UXO, likely dumped from a moving vessel. Most of the targets ensonified during the survey were located outside, but relatively adjacent to the dump boundary. Additional sonar contacts delineated on all survey lines indicated the trail of targets extended over most of the coverage area (Figure 5).

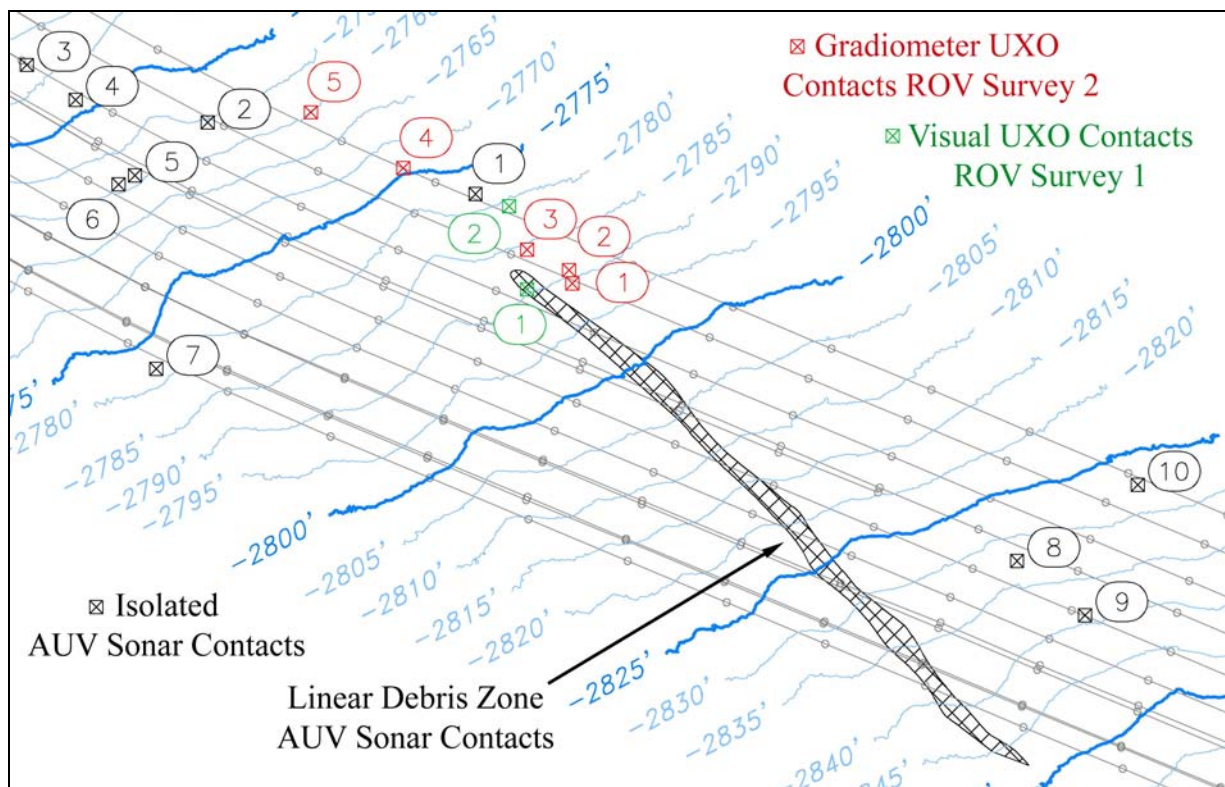
Figure 5: Combined Survey Results referenced to the AUV survey tracklines. Black contact symbols represent all sonar contacts interpreted in coverage area from 410 kHz AUV side scan sonar data. Green contact symbols represent only contacts reported to be UXO on seafloor from first ROV survey (Visual only). Red contact symbols represent only contacts reported to be UXO on seafloor or buried beneath the seafloor as interpreted from Gradiometer results from second ROV survey (Visual and Gradiometric data).

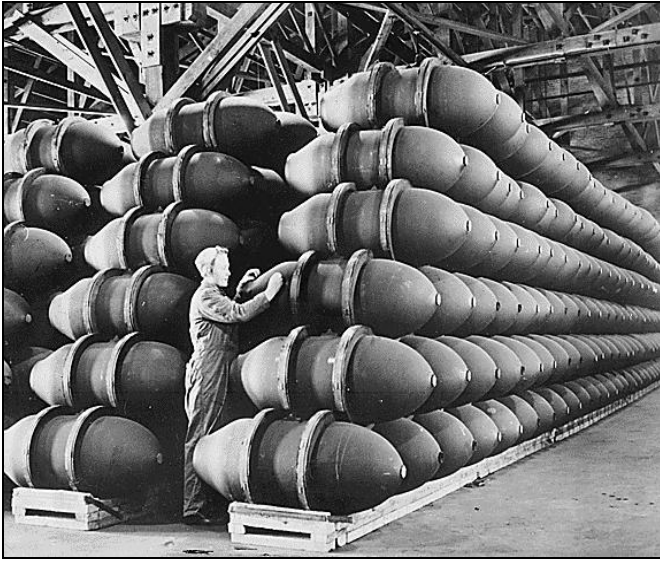
Figure 8: Stocked WWII 1,000-pound Bombs. Bombs dropped during WWII were highly explosive, a general-purpose bomb of 250; 500; or 1,000 pounds each¹⁵.

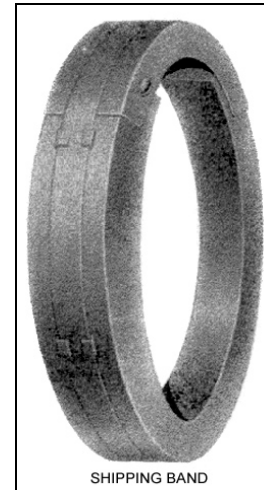
Figure 9: Shipping Band. Shipping bands similar to this one, are apparent in ROV photographs¹⁶.

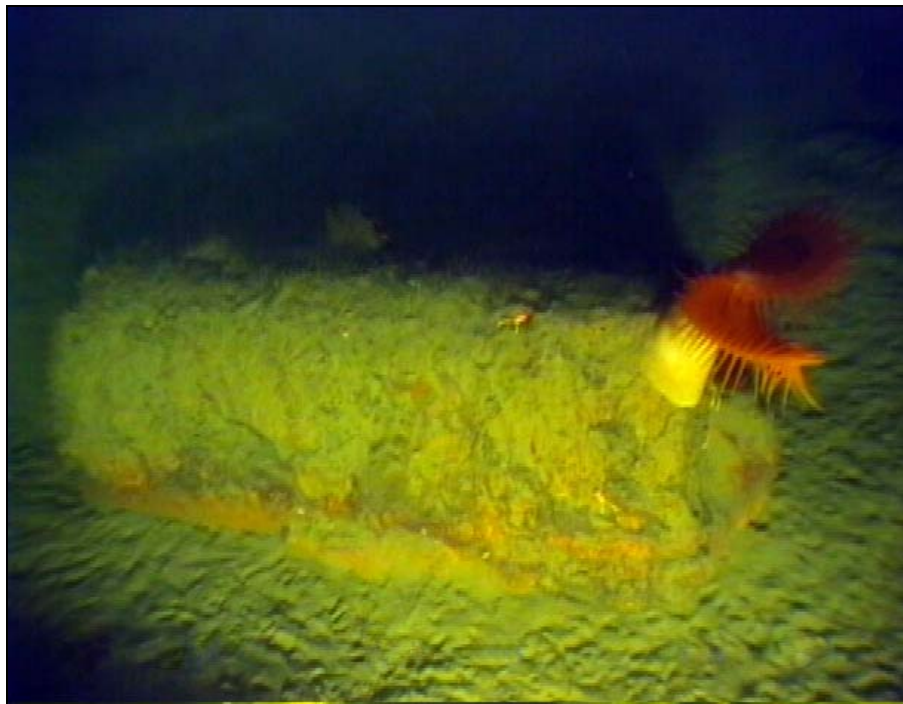
A Possible Torpedo Warhead was interpreted from the ROV image displayed in Figure 10. Dimensions and shape suggest it is a possible torpedo warhead with a blanking plate on the nose to the right (image orientation) where an acoustic hydrophone would be fitted once fully assembled. In this condition, the ordnance would be unarmed. An example of a pristine torpedo, which has similar dimensions/properties of the object in Figure 10, can be seen in Figure 11.

Figure 10: Possible Torpedo Warhead. Dimensions and shape suggest it is a possible torpedo warhead with a blanking plate on the nose where an acoustic hydrophone would be fitted once fully assembled. In this condition, the ordnance would be unarmed.

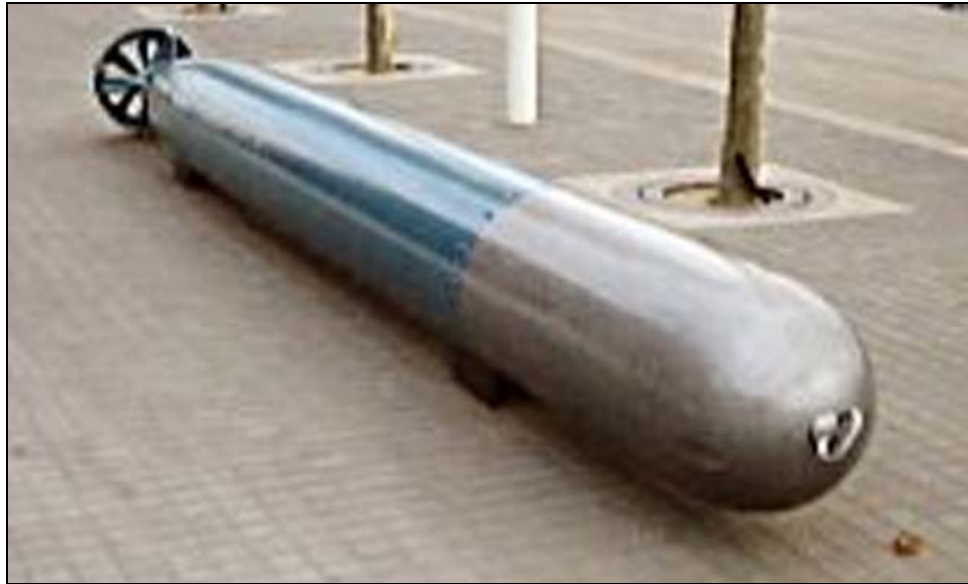
Figure 11: Example of a Pristine Torpedo. The object in Figure 10 appears to have the same physical properties as this torpedo¹⁷.
